F-8-127
Oakland; Hobbs-Smith Farmstead

Survey No. F-8-127
Oakland; Hobbs-Smith Farmstead
Libertytown, Maryland vicinity
Frederick County, Maryland

Maryland Historical Trust State Historic Sites Inventory Form

7.1 Description

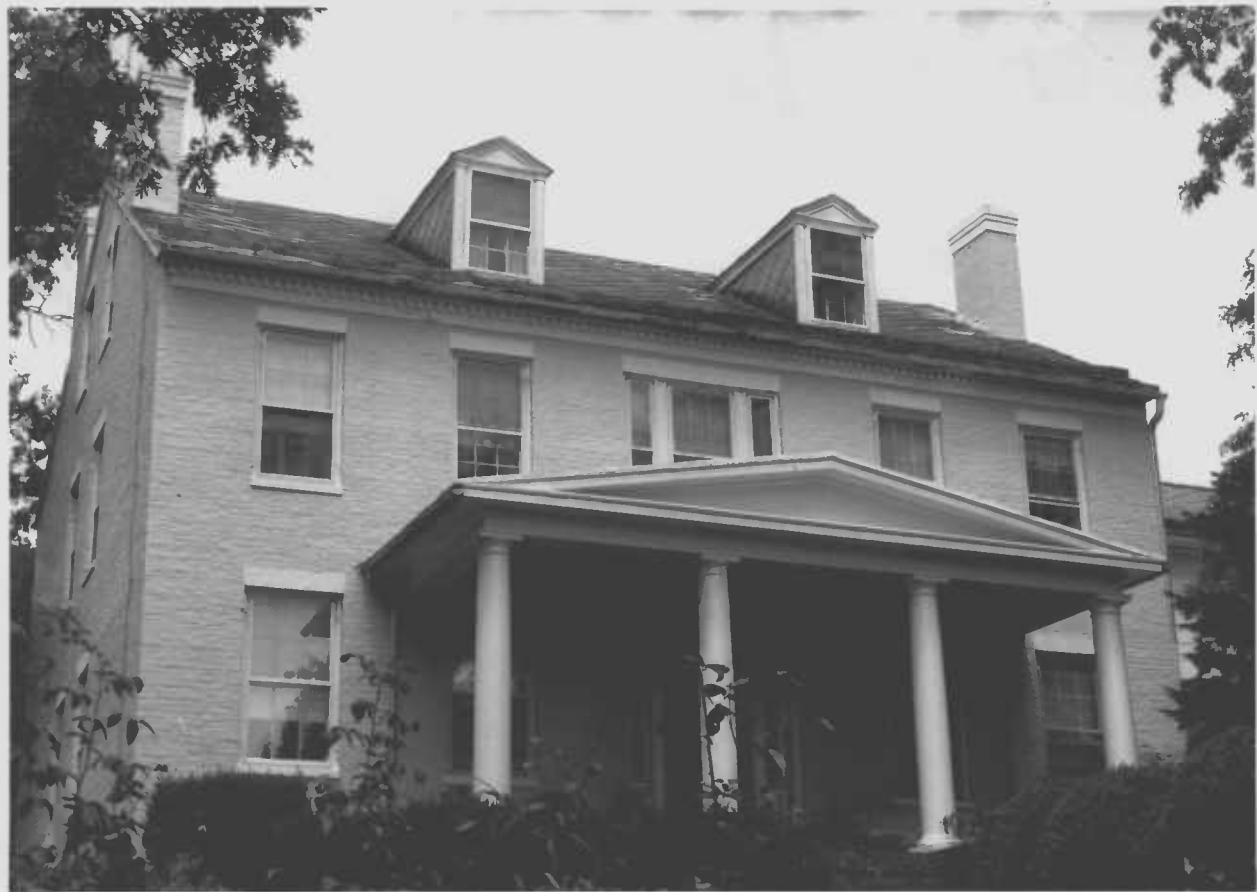
1/11

South elevation

The main dwelling house of Oakland is a five-bay, two-story brick structure with a two-story brick wing placed on the east end of the five-bay section. Both sections are 5-course American bond and are painted cream. A dentil cornice molding is on both sections. The main section has double interior end chimneys and a roof covered on the north by standing seam metal and composition shingles on the south. Two pedimented dormers project from the south slope of the roof; one dormer is located in the north roof. The main facade is dominated by a tetrastyle pedimented portico with Tuscan columns covering the central three bays. The window openings have gauged brick flat arches painted white. The sills are wood. The main entrance has double 8-paneled doors with sidelights and a 7-light transom. The second story center bay has a three-part window with narrow sidelights. The sash is 6/6. The rear elevation of the main section also has five bays with a one-story entry porch at the center entrance. The doorway has no sidelights, but does have a 7-light transom. The slender columns for the porch are placed on brick piers.

The brick wing is also two stories, but has a lower roofline than the main section. The south elevation is recessed from the plane of the main section front wall; the north elevation is flush with the main section. Originally, the wing had a two-story open porch on the south elevation, much as the side elevations of rear ells on other houses of the same period. In the 1940's, the porch was enclosed with concrete block and metal sash casement windows. The roof of the wing has the same materials as the main section roof. The north elevation has four bays; two contain doorways. The easternmost has a shed-roofed projecting foyer built around it. The westernmost door appears to be an early 20th century alteration of an original window opening. The windows in this elevation are 6/6 in the main section.

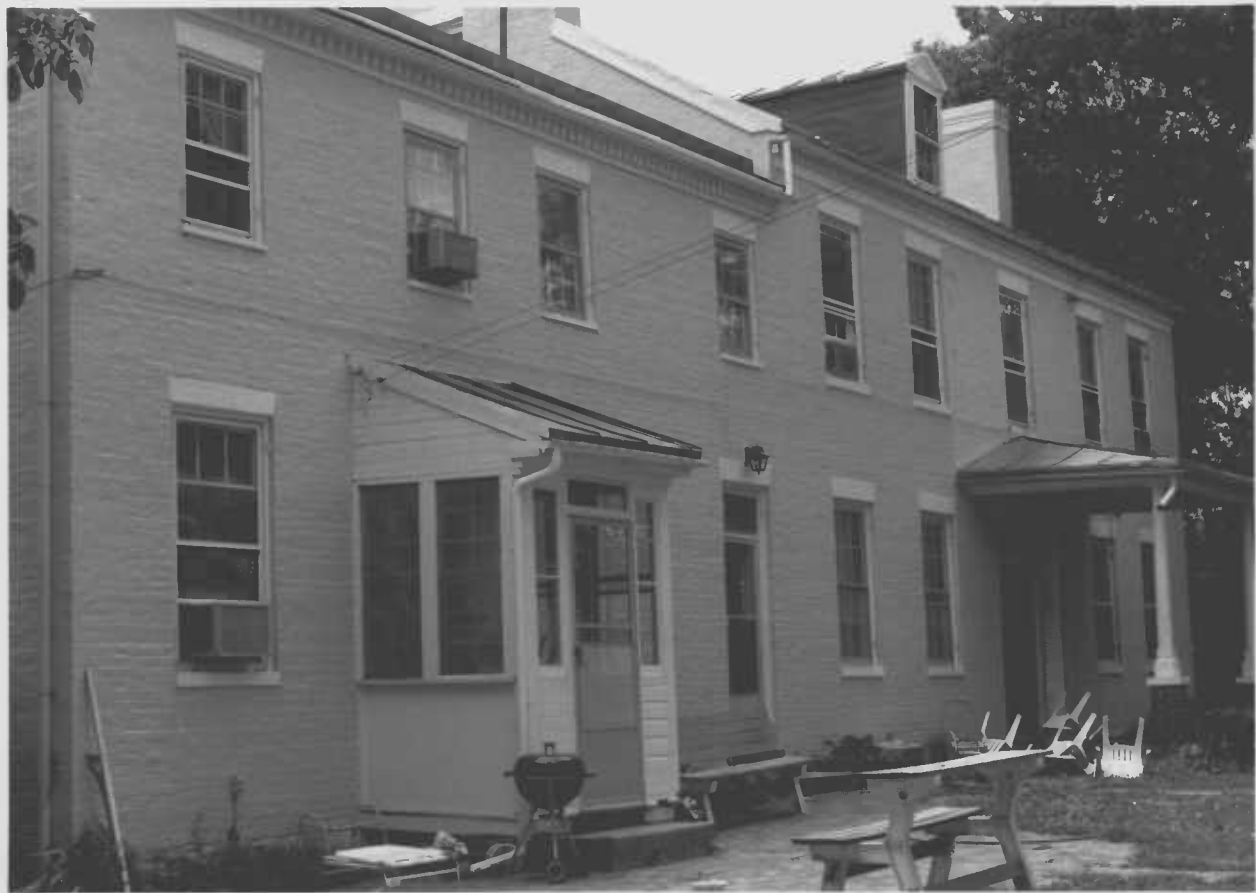
2/11

North elevation

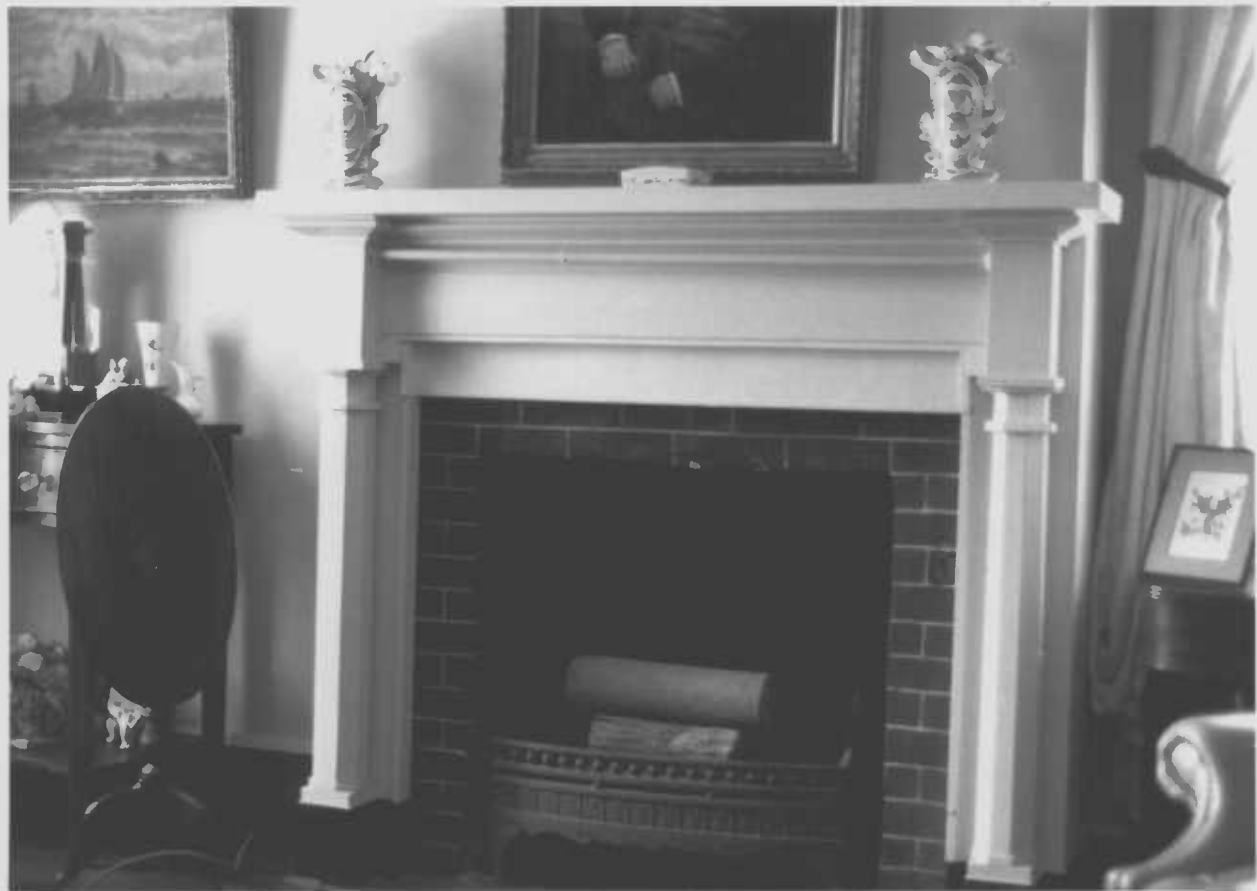
3/11

West parlor mantel

The interior plan is a symmetrical center hall plan with two rooms on each side of the hall. The stairs are located on the east wall and have scroll-sawn closer decoration. The trim is plain, with plain corner blocks at the window and doorframes. The flooring is wide boards. Each of the four main rooms on the first floor has a fireplace and Greek Revival mantel with flanking columns. According to the Smith family, the northeast corner room was used as the original kitchen; it is now a formal dining room. The doors have 6 raised panels. The walls are painted plaster.

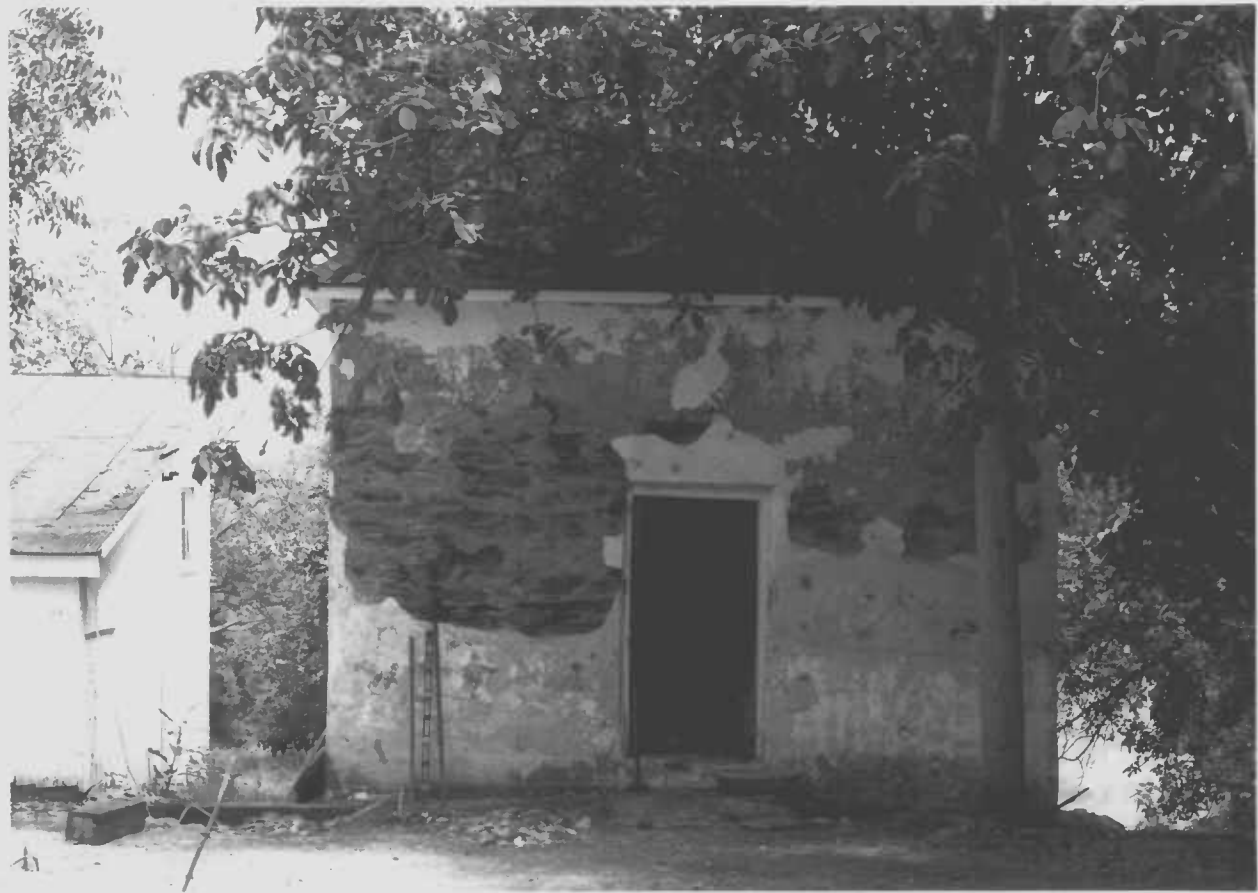
4/11

Smokehouse, west elevation

Smokehouse: This is a square plan, one-story building with plastered and whitewashed walls and a composition hipped roof. The single doorway is in the west elevation. A slit vent is located in the east wall. The smokehouse is probably circa 1850 in date.

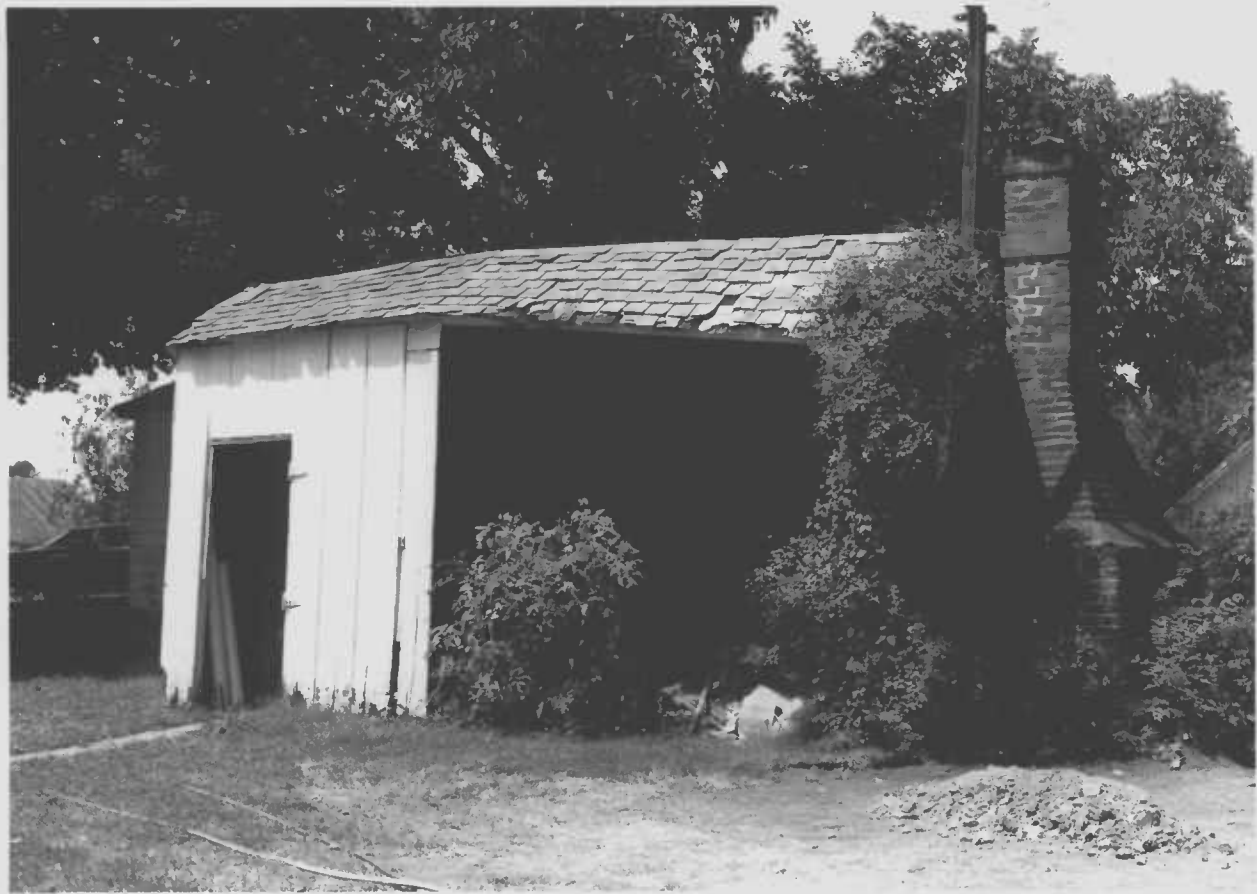
5/11

Summer Kitchen, south elevation

Summer kitchen: This one-story frame building has a saltbox roof with slate covering on the south elevation. The building is deteriorated and the exterior brick chimney is located on the east end with an open space between it and the opposite end of the building where a single doorway is framed in a remaining section of vertical boards. A farm bell is located on an iron pole at the southeast corner.

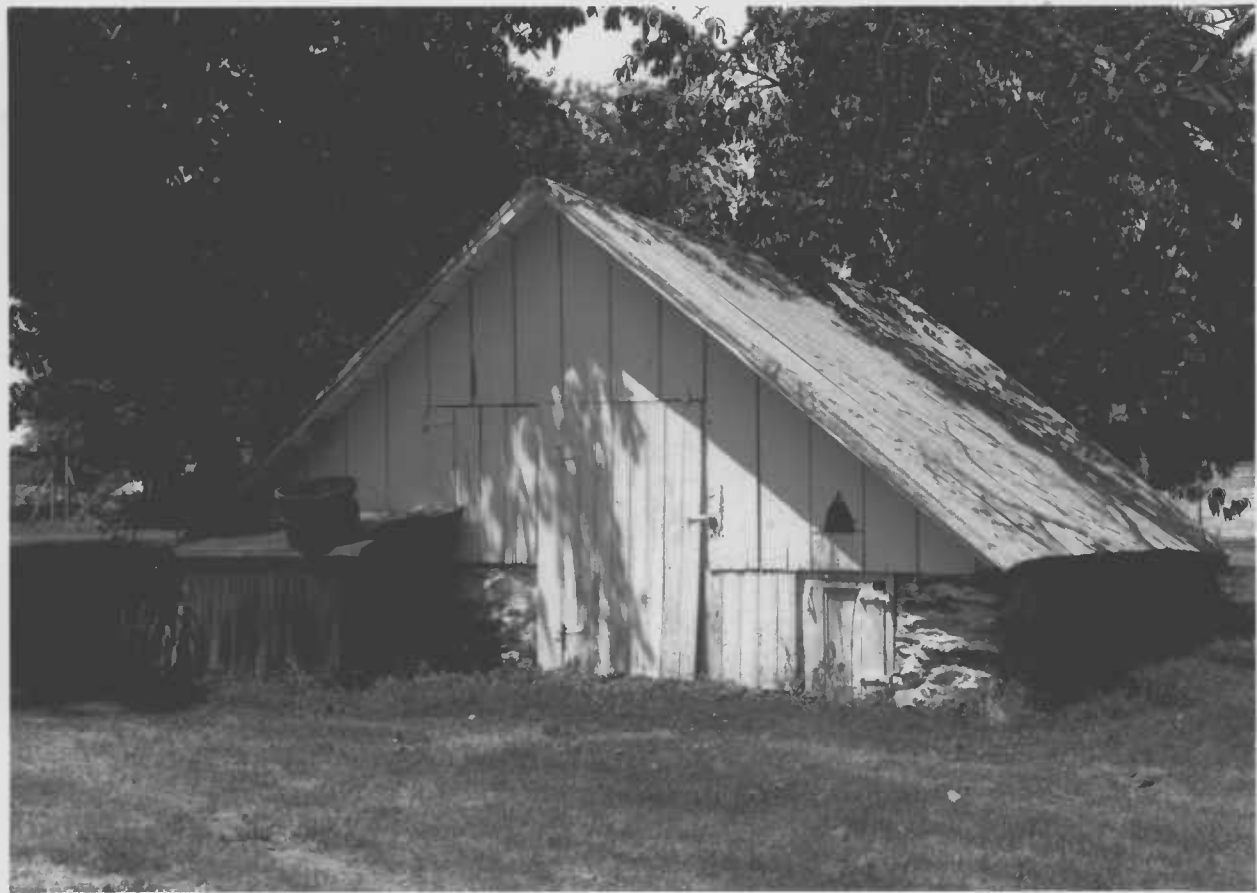
6/11

Ice house, south elevation

Ice house: The structure is stone with a rectangular plan and vertical board upper walls in the gable ends of the low roof of standing seam metal. The single entrance is a vertical board door in the south elevation. The ice house dates in the period 1875-1900.

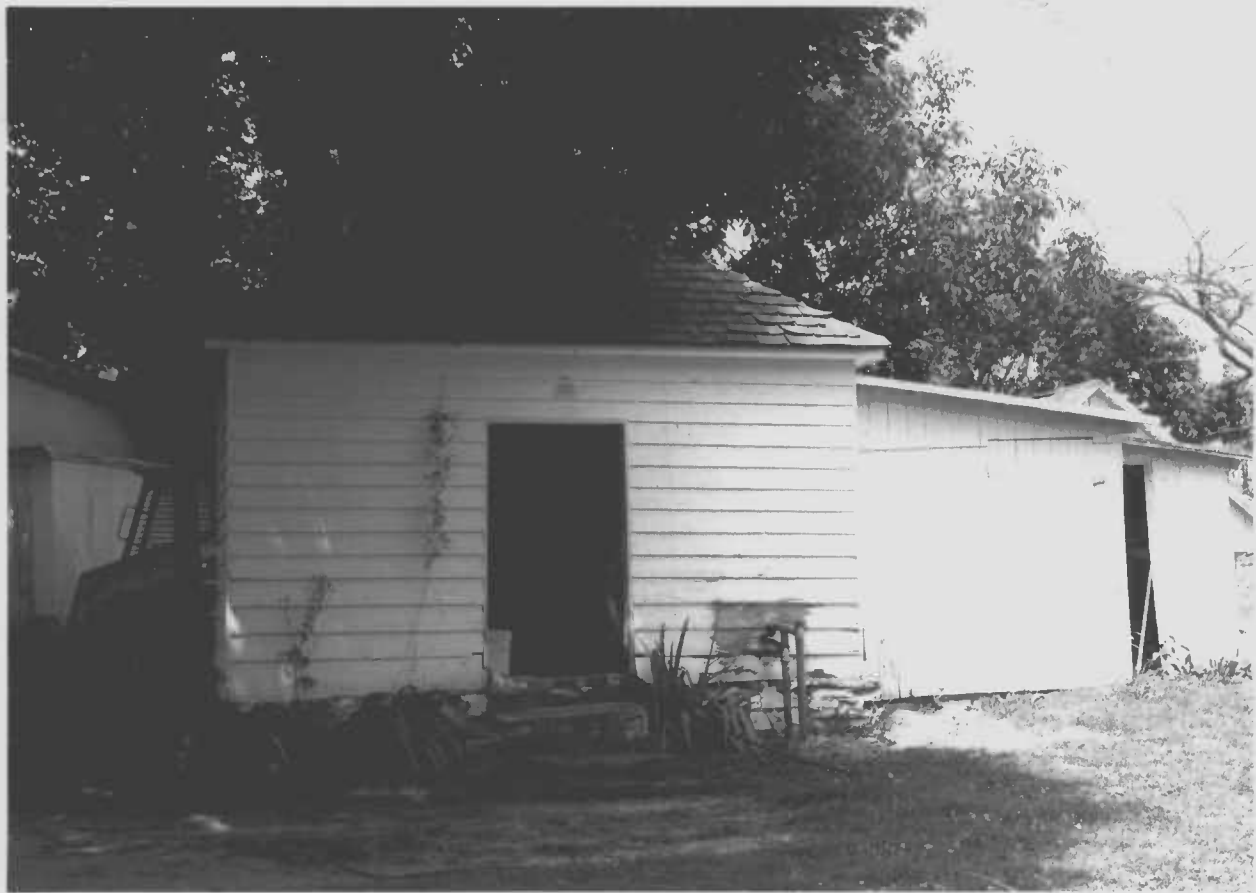
7/11

Dairy and tool shed, south elevation

Dairy/tool shed: This is essentially two adjoining buildings, with the tool shed being attached to the east elevation of the square plan frame dairy. The dairy roof is pyramidal with wood shingle covering. The siding is clapboard. The tool shed has vertical flush board siding. Both probably were built in the last quarter of the 19th century.

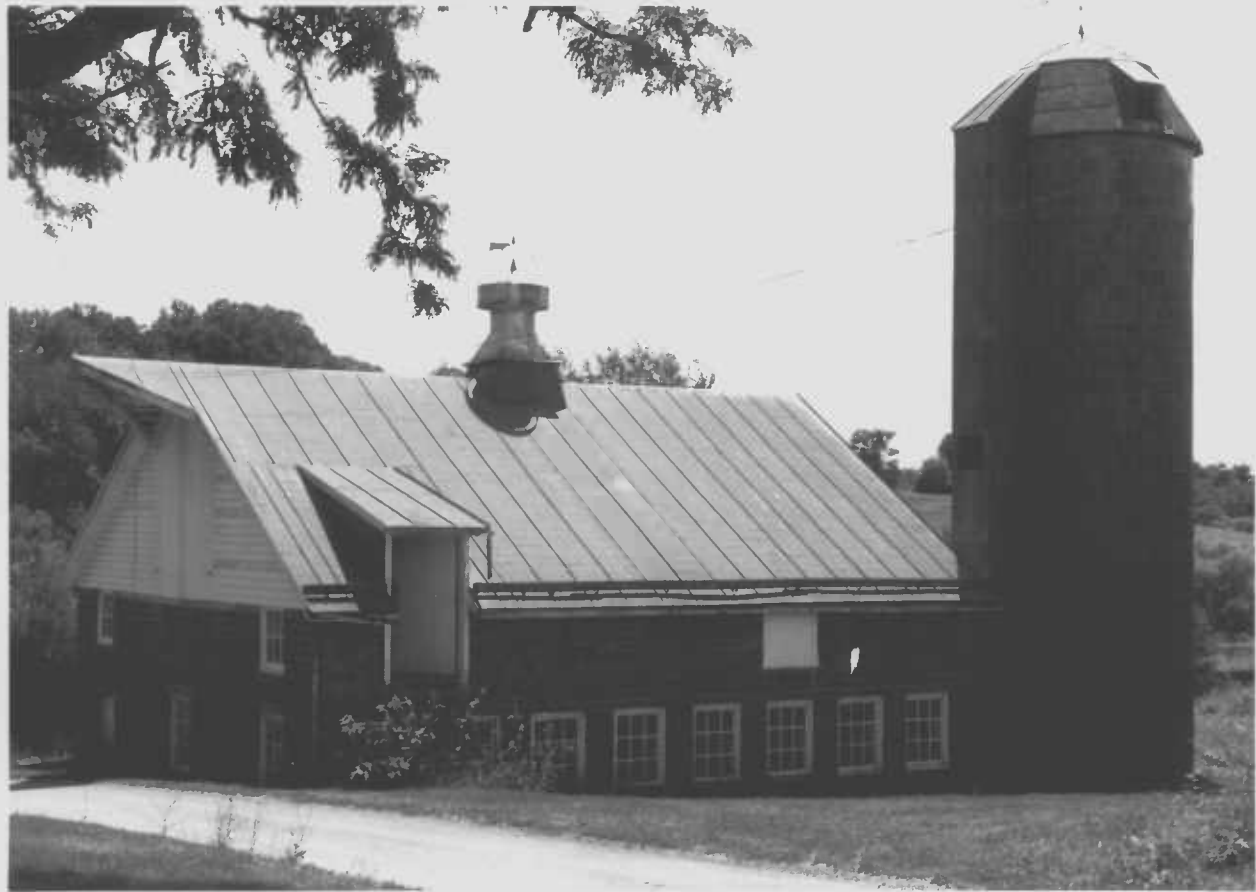
8/11

Dairy barn and silo, north elevation

Dairy barn: This is a circa 1940 terra cotta tile and frame structure with a gambrel roof and a central metal ventilator. The roof is standing seam metal and the main loading doors for feed are in the east elevation facing the driveway. A second loading door is located in the north elevation.

Silo: A terra cotta tile silo apparently built at the same time as the dairy barn and milk house is located at the northwest corner of the dairy barn. It has a standing seam cap with a shed opening in the northeast side.

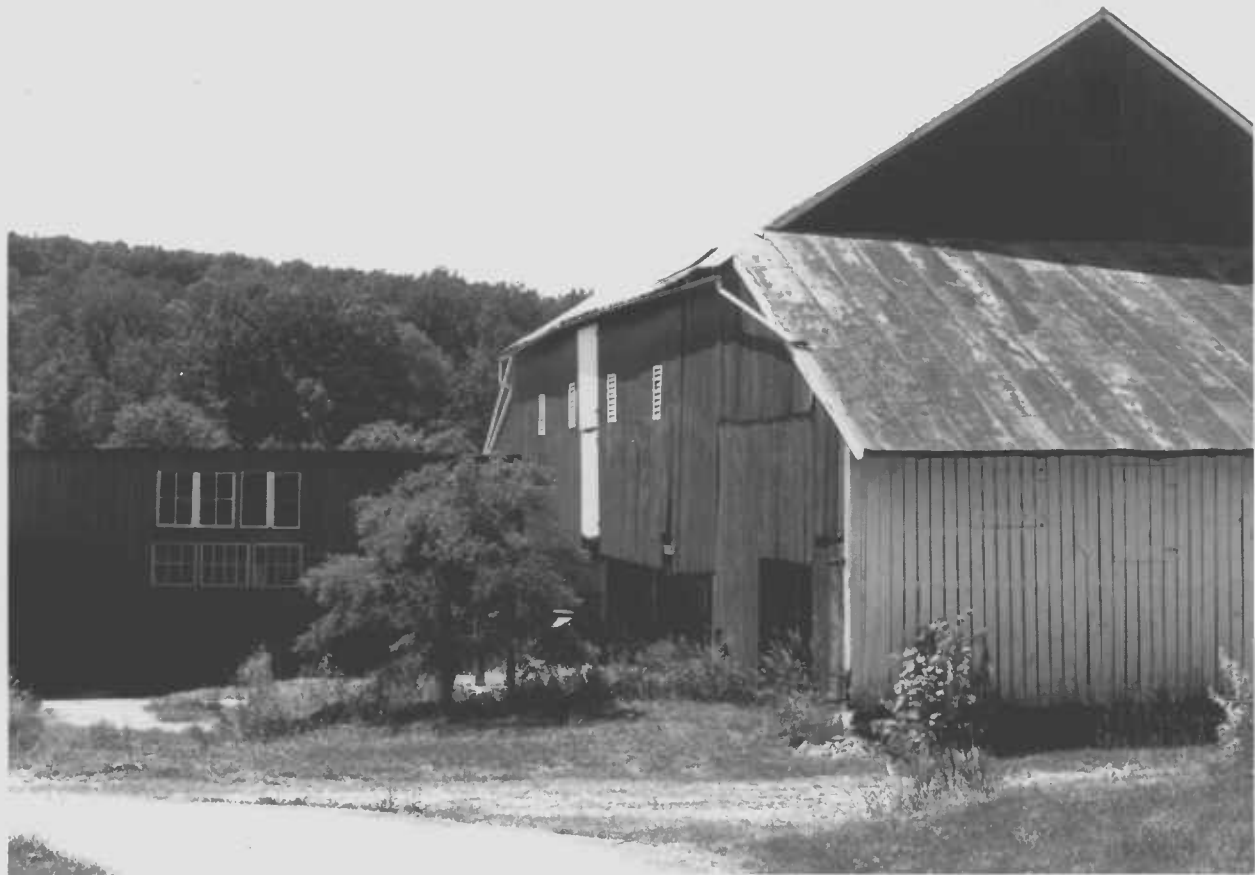
9/11

Bont barn, east elevation

Bank barn: The original structure of the barn possibly dates from the 1850's. Shed additions are located at the east and west gable ends, housing wagon shed and corn cribs. The roof of the barn is standing seam metal. The south elevation forebay reveals two feeding aisles with a single drive floor on the upper level. The siding is vertical flush boards and louvered vents are on each elevation.

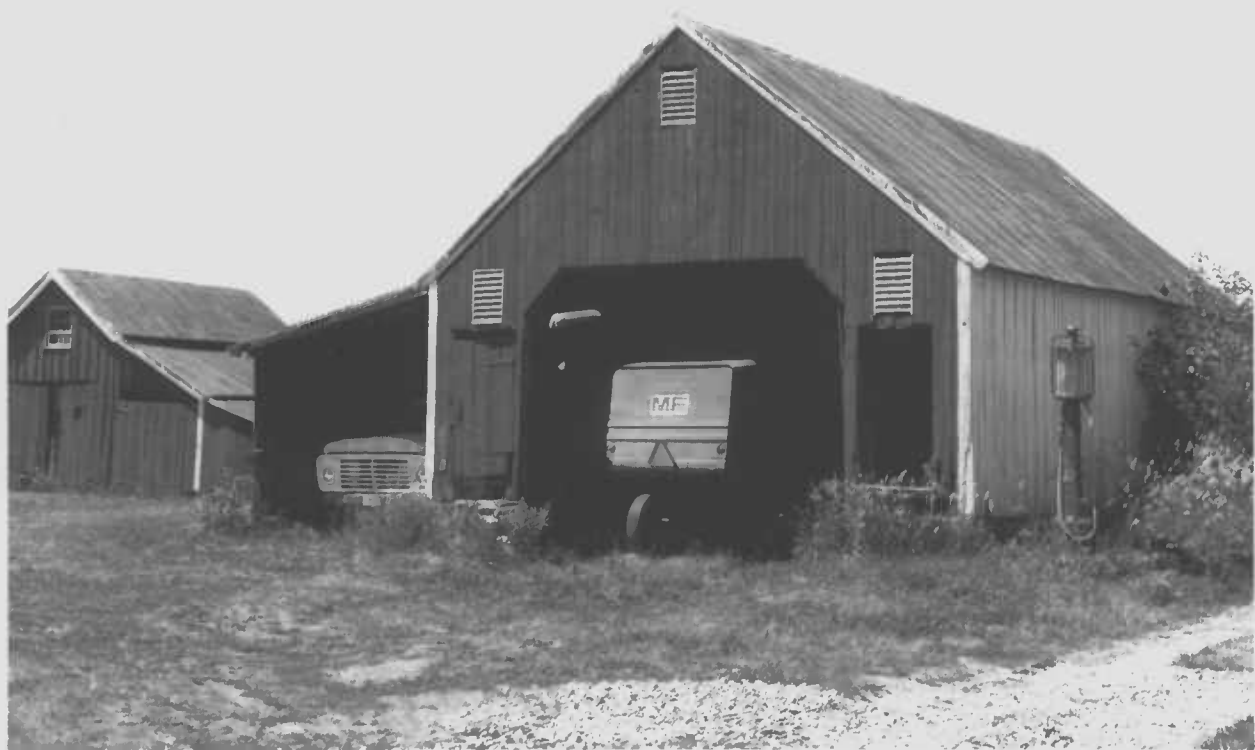
Neg. loc.: Md. SHPO, Crownsville, Md.
Corn crib/wagon shed, south elevation
10/11

Corn crib/wagon shed: This building possibly dates from the period 1875-1900 and is a frame building with double bins, vertical siding, and a standing seam gable roof. Next to the corn crib on the southeast corner is an early 1920's gasoline pump with a glass cylinder top.

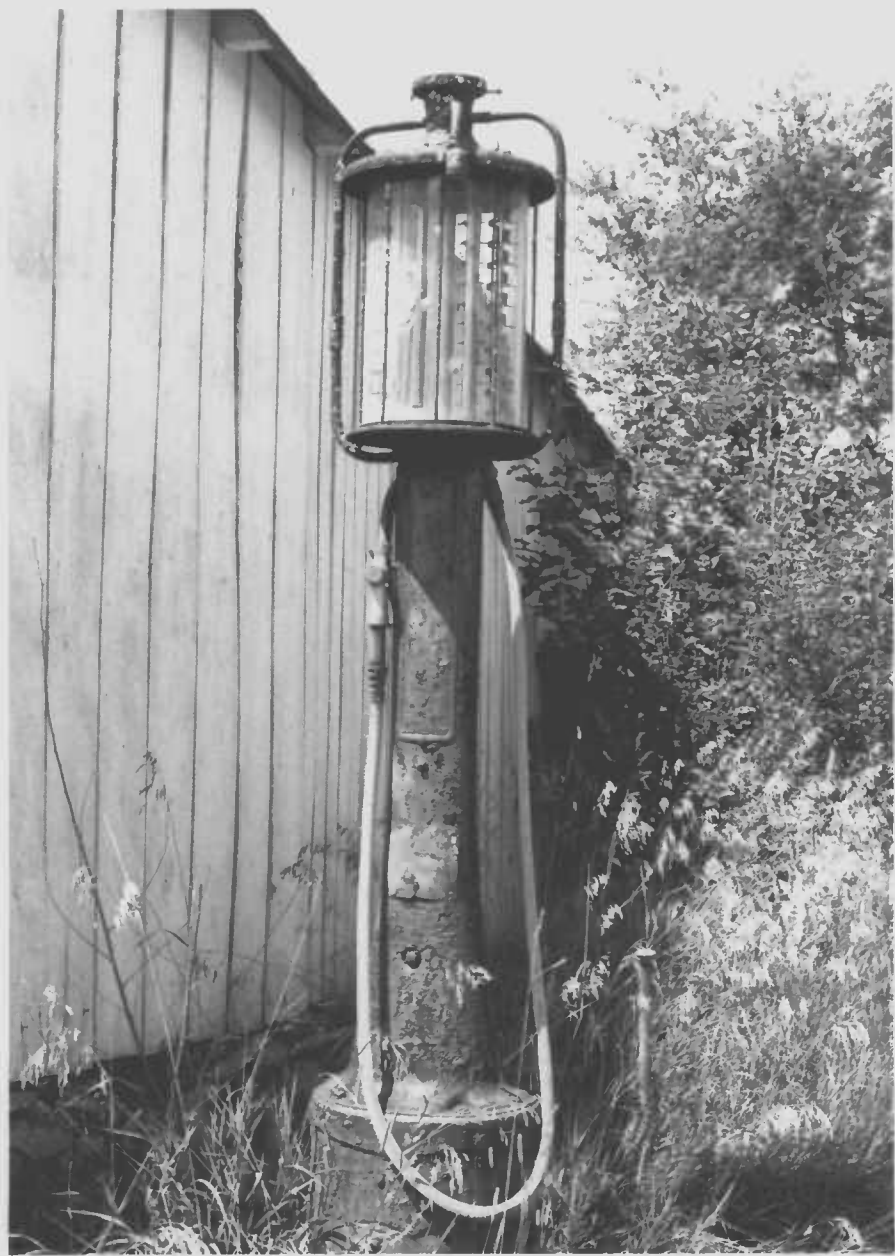
11/11

Gas pump
